**Purpose: CERCLA Preliminary Assessment**

**Site: Geer Road Landfill  
751 Geer Road  
Modesto, California  
Stanislaus County**

**Site EPA ID Number: CAD983578097**

**Date of Inspection: October 7, 1991**

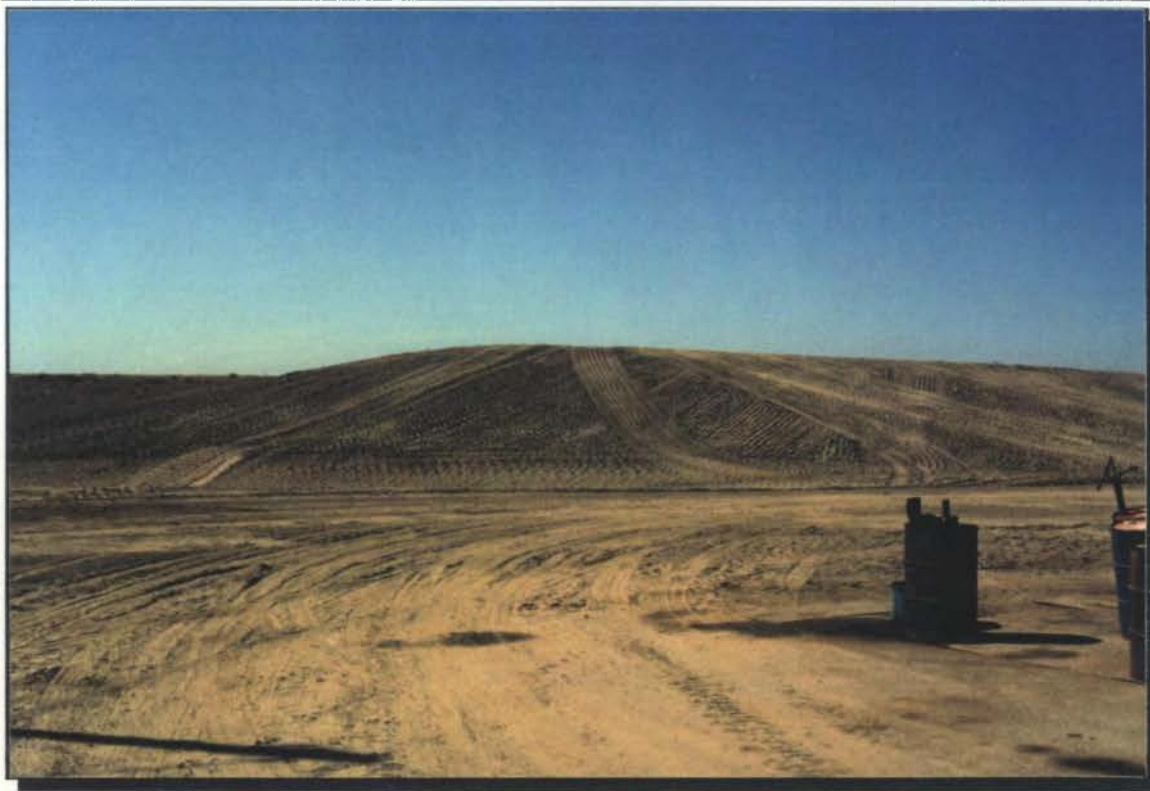
## PHOTO #2

**DESCRIPTION:** View of landfill looking south. The surface of the landfill is being regraded and covered with clean soil.

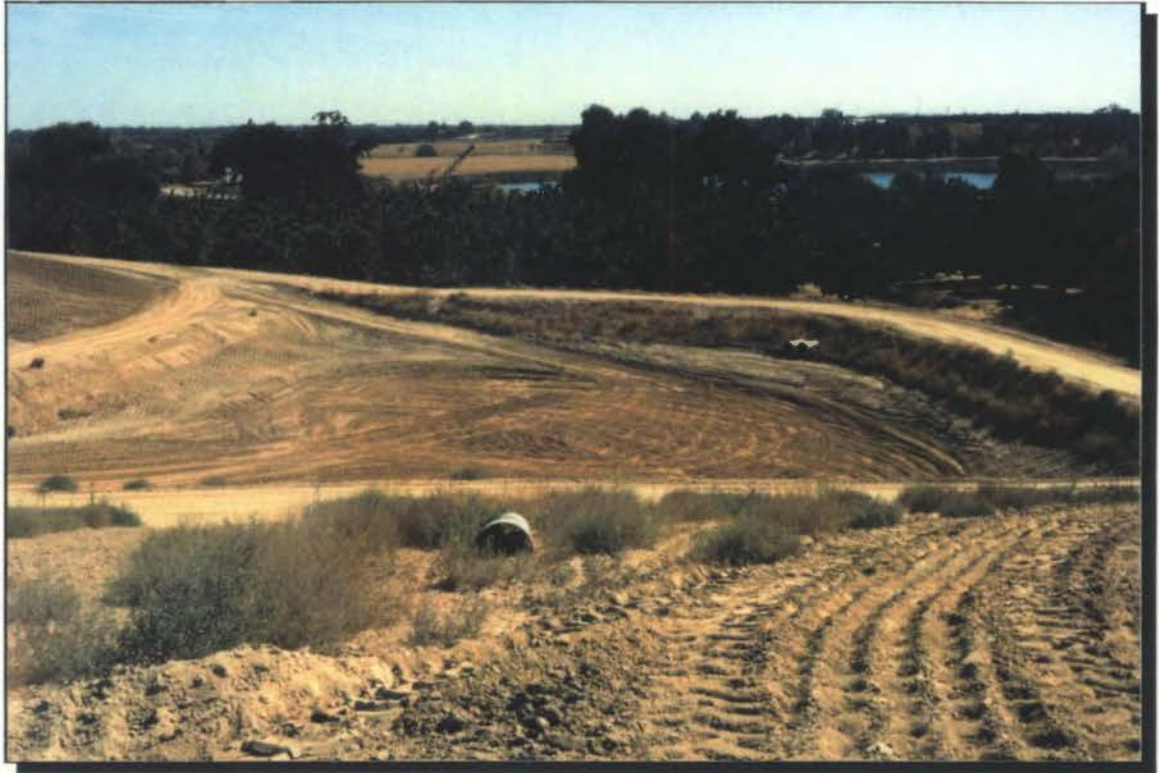
**DESCRIPTION:** View of recently re-constructed sedimentation basin. This basin captures runoff from the surface of the landfill. The Tuolumne River is in the background.

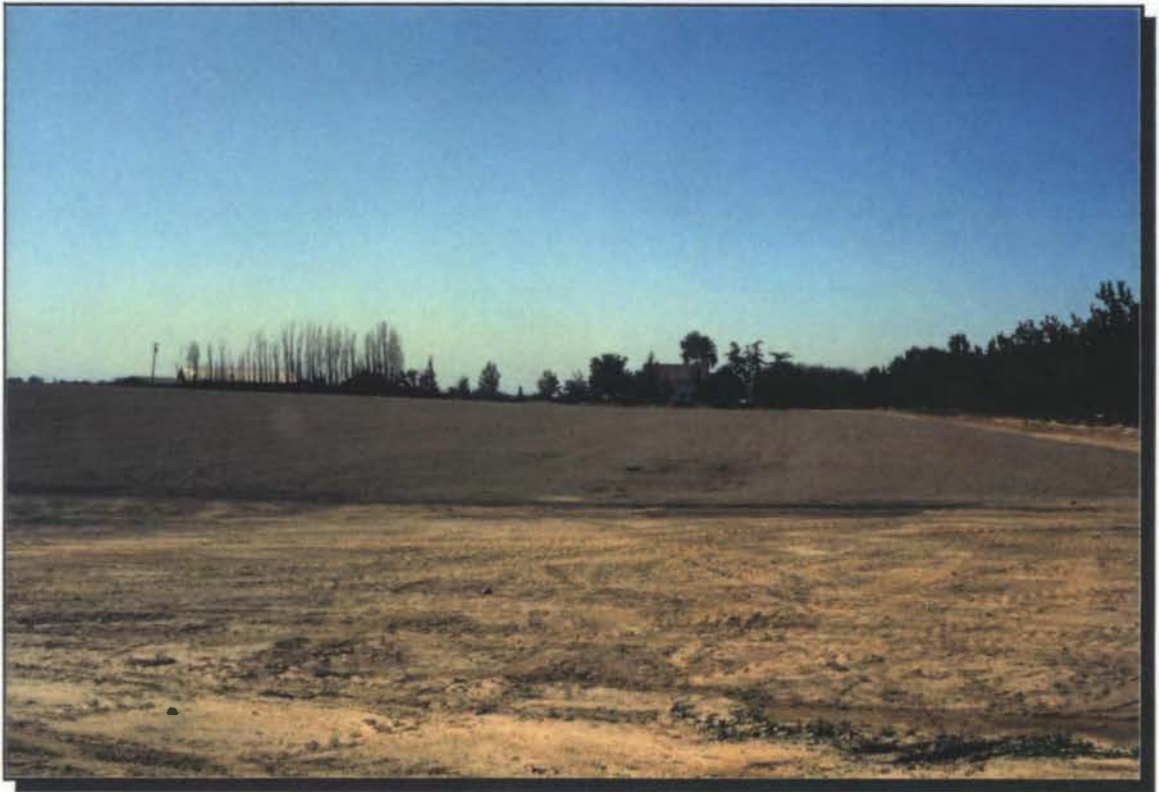
**PHOTO #4**

**DESCRIPTION:** North end of landfill. View indicates nearest residence just beyond the landfill boundary.
